Contract #: 04-0120F4Cty: SF/ALA Rte: 80 PM: 13.2/13.9File #: 69.28**WELDING INSPECTION REPORT****Resident Engineer:**Pursell, Gary**Address:** 333 Burma Road**City:** Oakland, CA 94607**Report No:** WIR-013291**Date Inspected:** 14-Mar-2010**Project Name:** SAS Superstructure**OSM Arrival Time:** 700**Prime Contractor:** American Bridge/Fluor Enterprises, a JV**OSM Departure Time:** 1900**Contractor:** Zhenhua Port Machinery Company, Ltd (ZPMC), Changxing Island **Location:** Shanghai, China**CWI Name:** Yu Dong Ping, Tu Jun**CWI Present:** Yes No**Inspected CWI report:** Yes No N/A**Rod Oven in Use:** Yes No N/A**Electrode to specification:** Yes No N/A**Weld Procedures Followed:** Yes No N/A**Qualified Welders:** Yes No N/A**Verified Joint Fit-up:** Yes No N/A**Approved Drawings:** Yes No N/A**Approved WPS:** Yes No N/A**Delayed / Cancelled:** Yes No N/A**Bridge No:** 34-0006**Component:** Tower**Summary of Items Observed:**

Bay 11, Tower Lift 4 Strut

WELDING INSPECTION REPORT

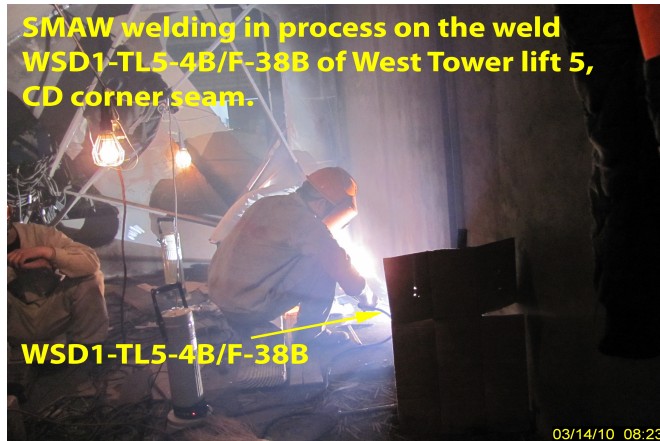
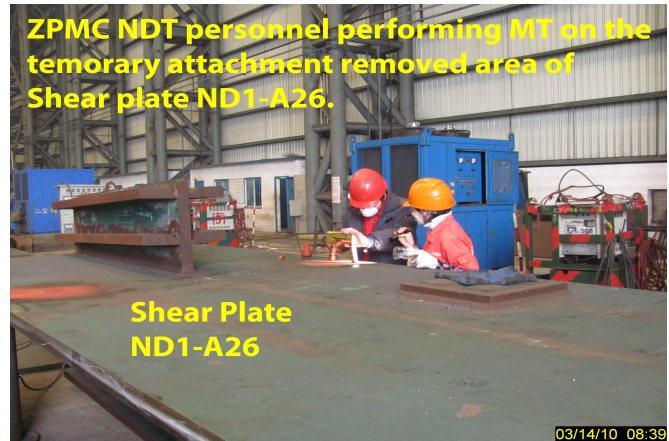
This QA inspector observed that ZPMC NDT personnel were performing Magnetic Particle Testing (MT) on the temporary attachment removal area of shear plate ND1- A26. Attached photographs provide additional details.
